Asbestos-Containing Materials Reassessment - 2021

Formerly Keys Public School – Deep River, ON

**ASBESTOS-CONTAINING MATERIAL
REASSESSMENT – 2021
FORMERLY KEYS PUBLIC SCHOOL
BROCKHOUSE WAY
DEEP RIVER, ON**

CM3 Project # RM3128
November 2021

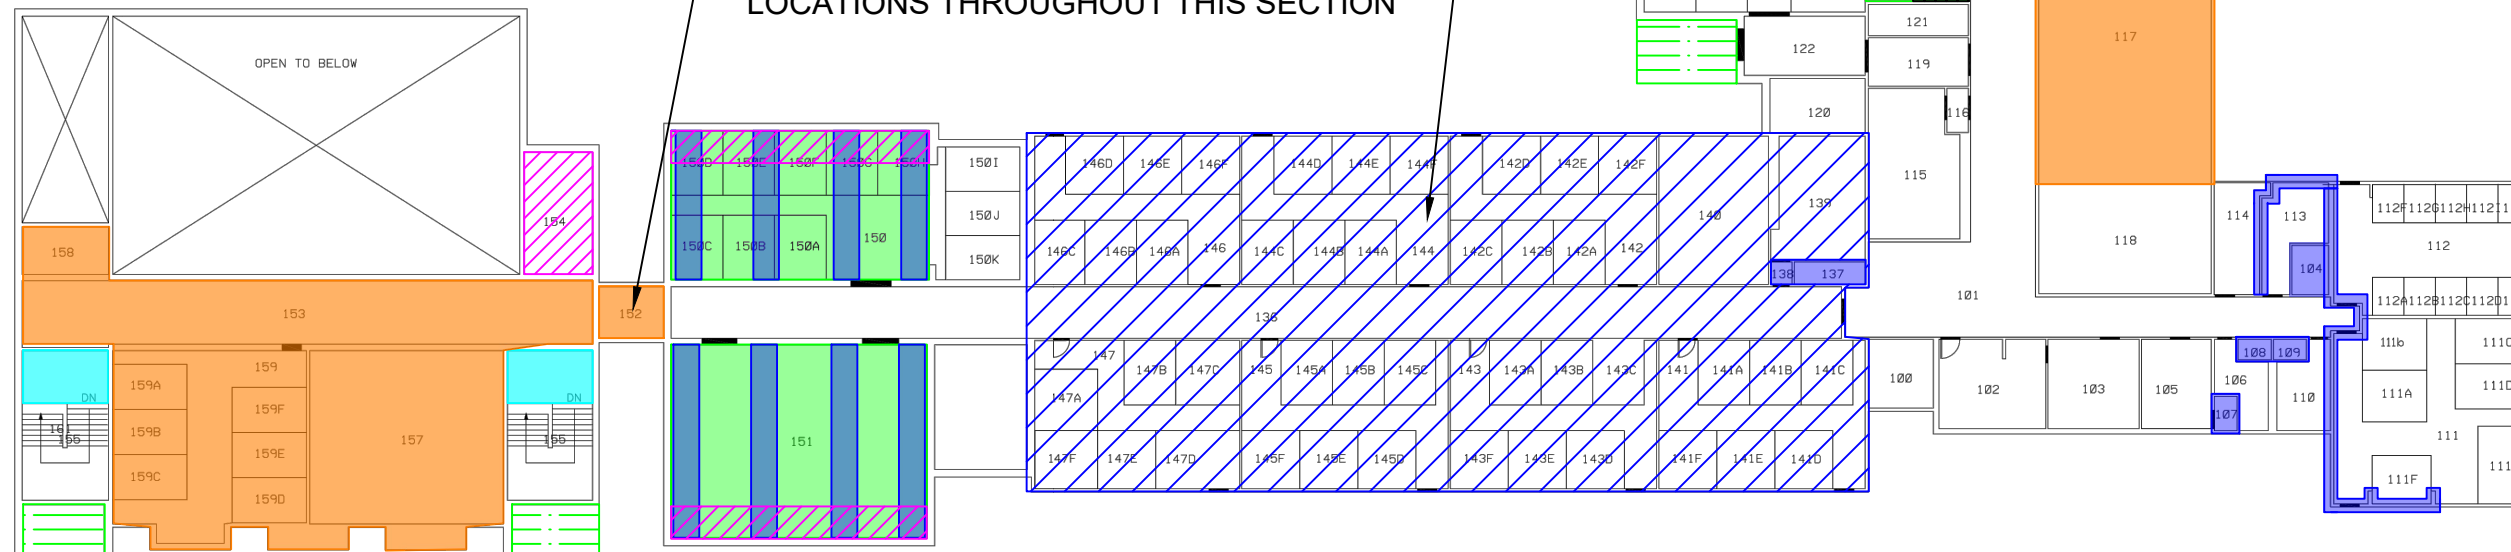
B889
FIRST FLOOR

ACM TRANSITE PANELS AND MECHANICAL INSULATION

ACM 2'x4' ACOUSTIC CEILING TILES

ACM DRYWALL JOINT COMPOUND ON BULKHEADS IN RANDOM LOCATIONS THROUGHOUT THIS SECTION

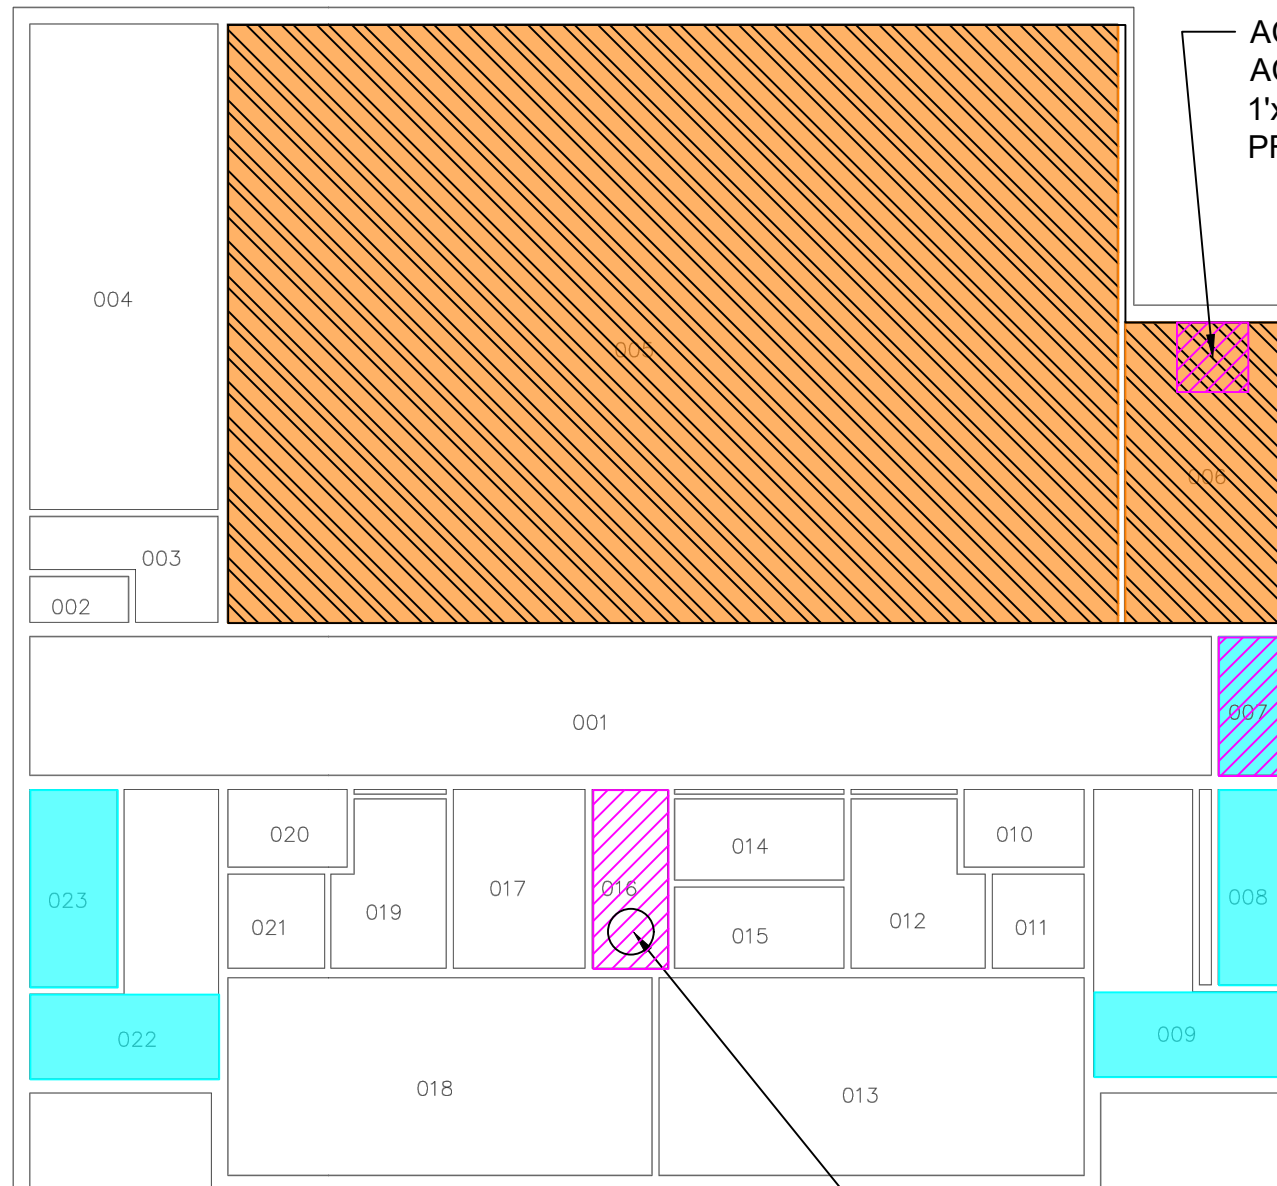
B889 Keys Campus
Basement

ACM MECHANICAL PIPE INSULATION, ACM VINYL FLOOR TILES AND ACM 1'x1' CEILING TILES AND MASTIC PRESENT IN ROOM 006
