Roof Asset Management Program

20221027 - Keys Building - Roof Inspection & Recommendations

Subject: Roof Inspection- Keys School

Facility: Keys Building

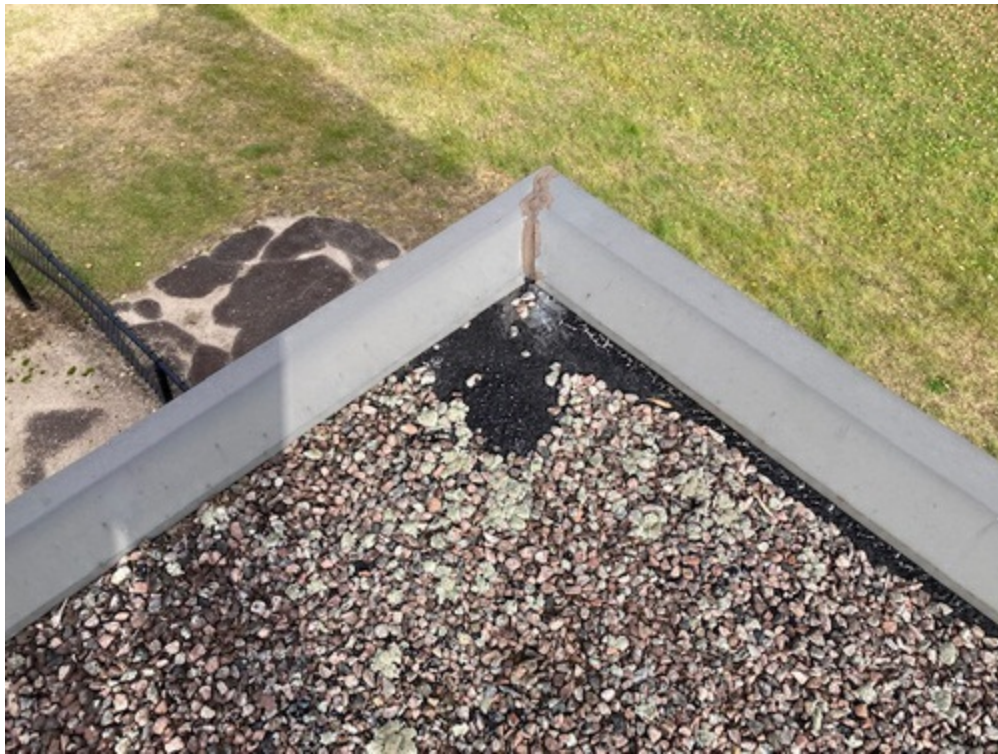
Photo 5

Confirmation of wind scour area.

Wind Scour is a common phenomenon as wind speed increases as the air is pushed over the roof of the building after it impacts the walls. This is typical to the same properties with an airplane wing. This causes a vortex in air circulation creating negative pressure at the roof surface. Loose aggregate or ballast is easily moved under these conditions. Roof aggregate or ballast serves a few functions, 1) to protect the surface of the roof system from UV degradation while increasing the fire rating of the assembly and 2) to hold the roof system in place specifically on ballasted systems. If areas of the roof are exposed due to wind scour, protection of the roof to the elements is also removed and in the case of ballasted roof systems damage and eventual blow off of the system can occur.

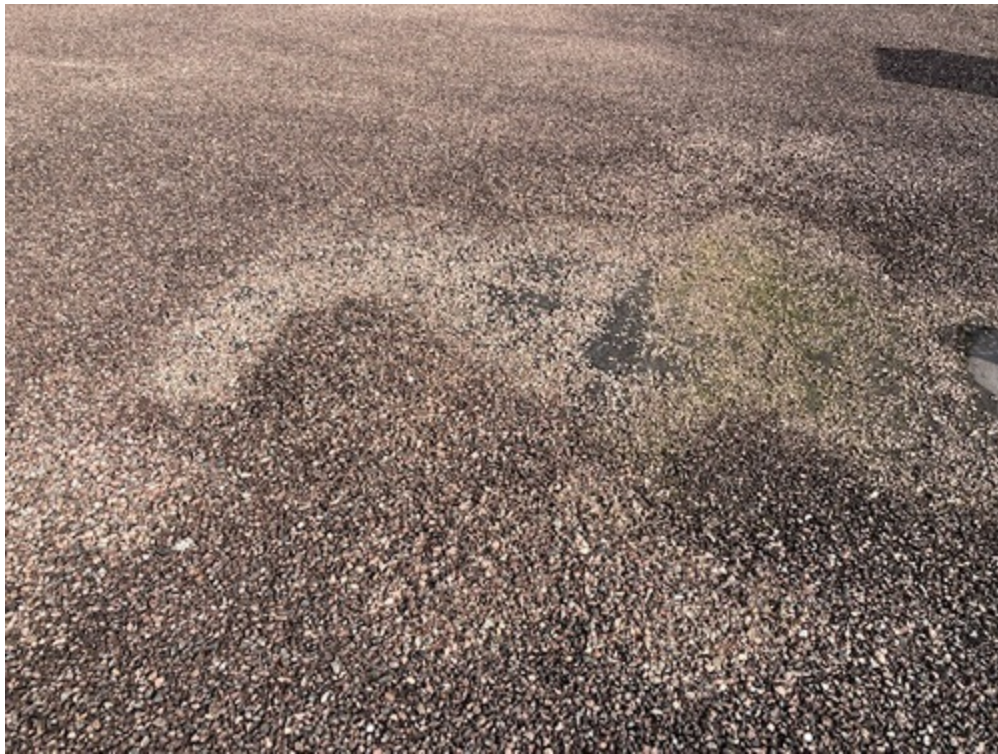
Photo 5

Confirmation of wind scour area.

Wind Scour is a common phenomenon as wind speed increases as the air is pushed over the roof of the building after it impacts the walls. This is typical to the same properties with an airplane wing. This causes a vortex in air circulation creating negative pressure at the roof surface. Loose aggregate or ballast is easily moved under these conditions. Roof aggregate or ballast serves a few functions, 1) to protect the surface of the roof system from UV degradation while increasing the fire rating of the assembly and 2) to hold the roof system in place specifically on ballasted systems. If areas of the roof are exposed due to wind scour, protection of the roof to the elements is also removed and in the case of ballasted roof systems damage and eventual blow off of the system can occur.

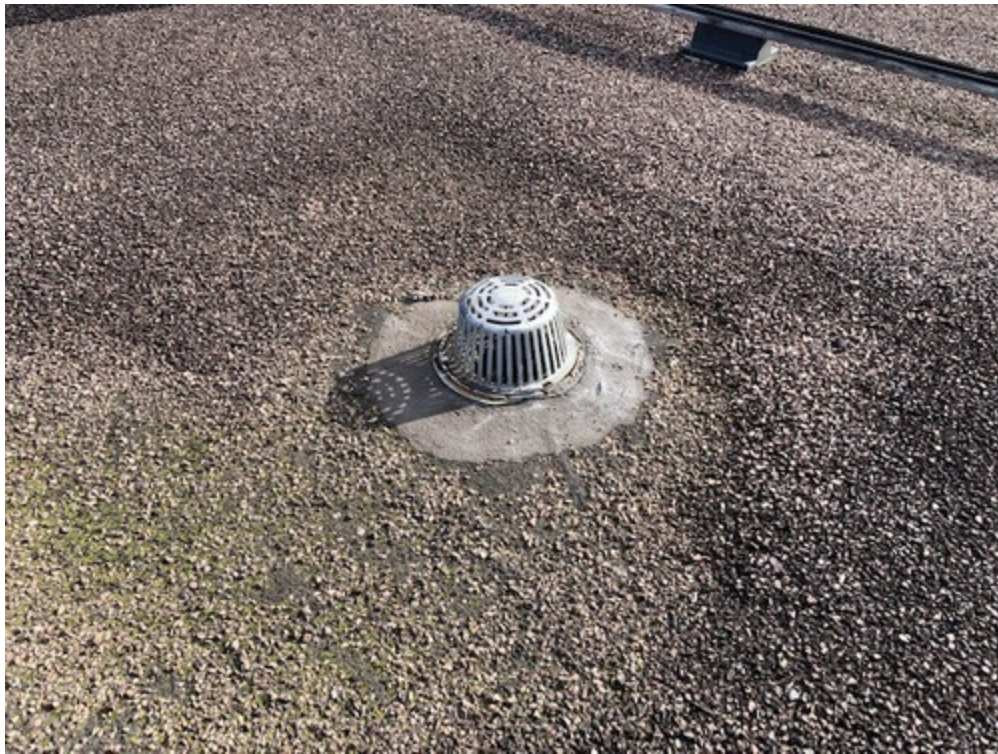
Photo 6

Confirmation of previous repair around the drain.

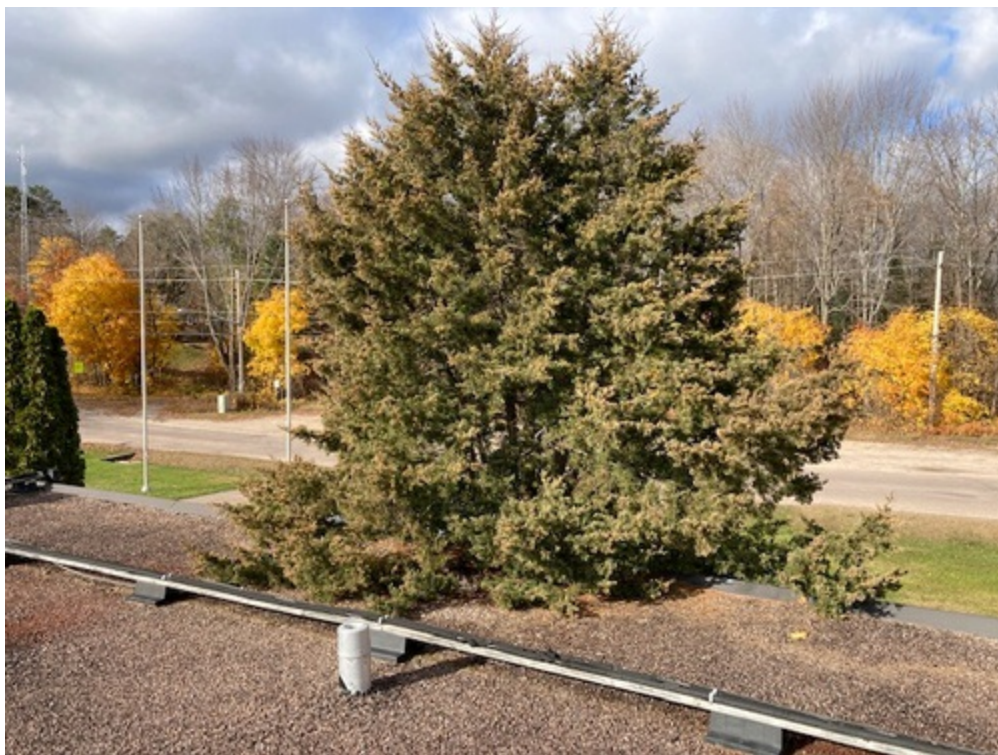
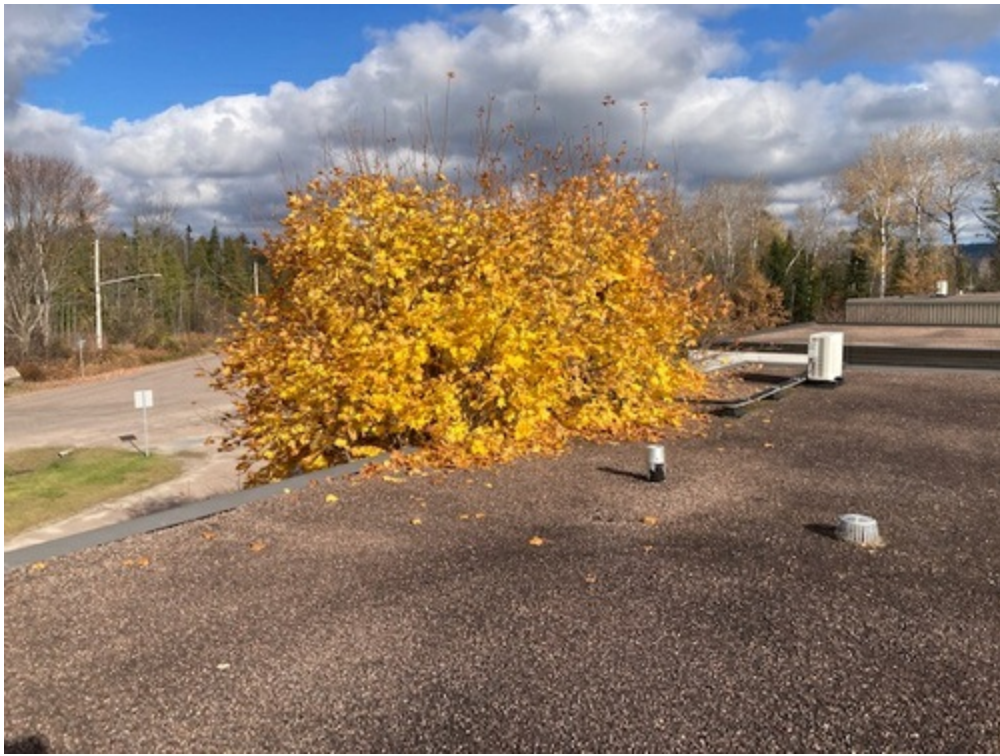
The next two (2) photos are confirmation of trees along the parapet wall. The trees should be cut back away from the roof.

Debris - Leafs and Pine

Needles: Pine needles and other leaves build up on the roof membrane causing plugged drains and scuppers thereby causing ponding water and structural weight loading. As the leaves and pine needles rot a "compost effect" occurs, this in effect causes soil to form on top of the roof membrane. This soil creates a perfect medium for plant and weed growth. When seeds take hold the roots will often penetrate through the membrane causing immediate leaks and damage internally.

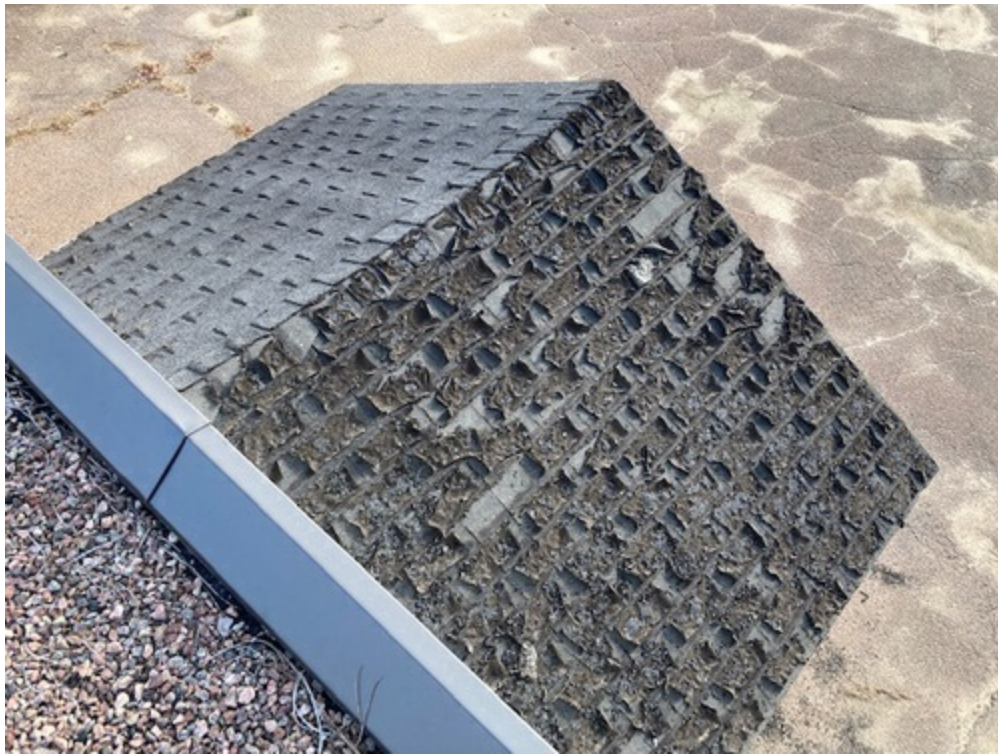
Photo 5

Confirmation of deteriorated shingles attached to the building.

Shingle Deterioration: As organic three-tab shingles are exposed to the elements they become brittle and shrink. This in turn causes the shingle to "crumble" and "curl". Once the mineral surfacing "crumbles" apart it exposes the underlying organic felt, which rapidly deteriorate when exposed to freeze/thaw cycles. This in turn allows ice and water to enter the building causing internal damage and leaks.

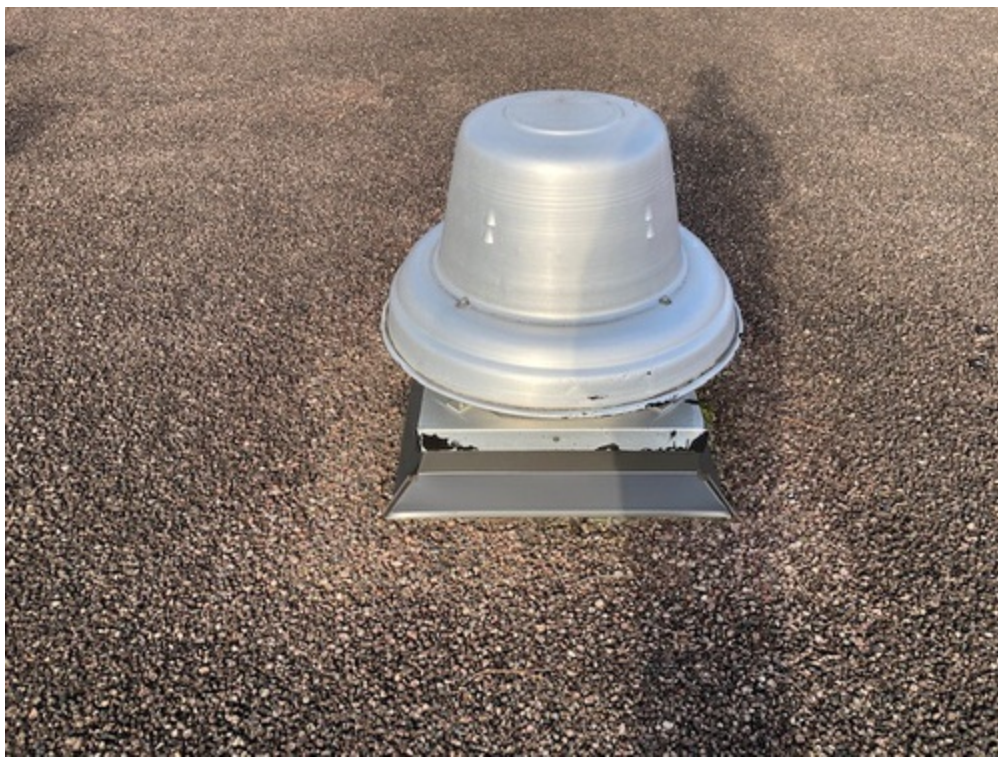
Photo 6

Confirmation of existing vent. During the next roof replacement, ensure curb is above the finished roof height by 12".

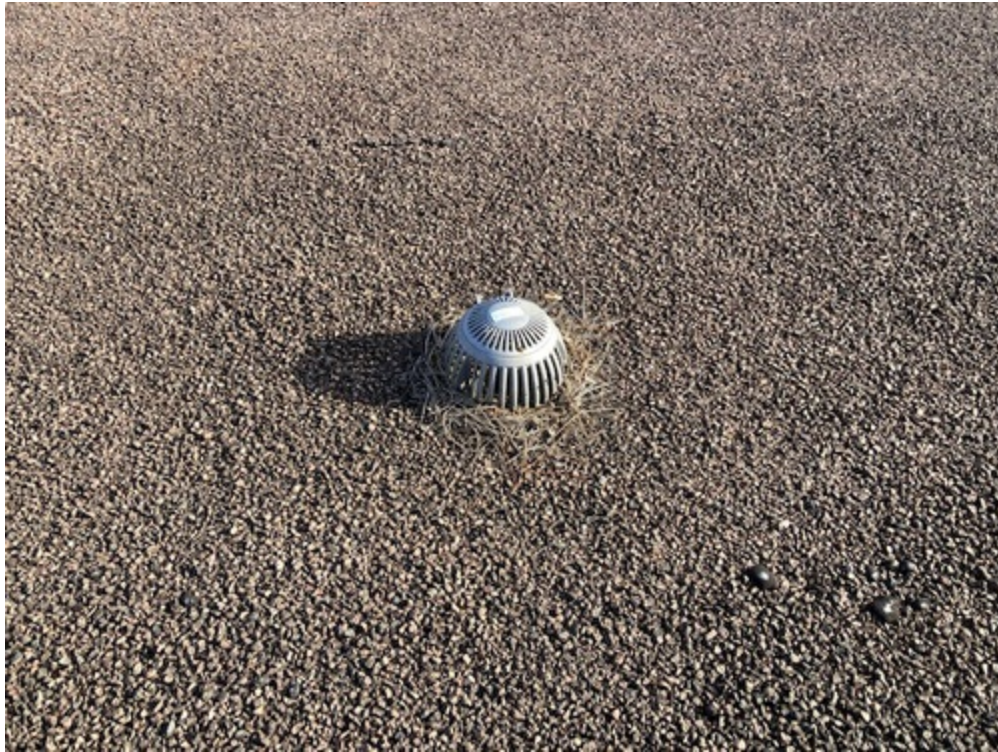
Photo 7

Confirmation of clogged drains due to debris.

Debris - Leaves and Pine Needles: Pine needles and other leaves build up on the roof membrane causing plugged drains and scuppers thereby causing ponding water and structural weight loading. As the leaves and pine needles rot a "compost effect" occurs, this in effect causes soil to form on top of the roof membrane. This soil creates a perfect medium for plant and weed growth. When seeds take hold the roots will often penetrate through the membrane causing immediate leaks and damage internally.

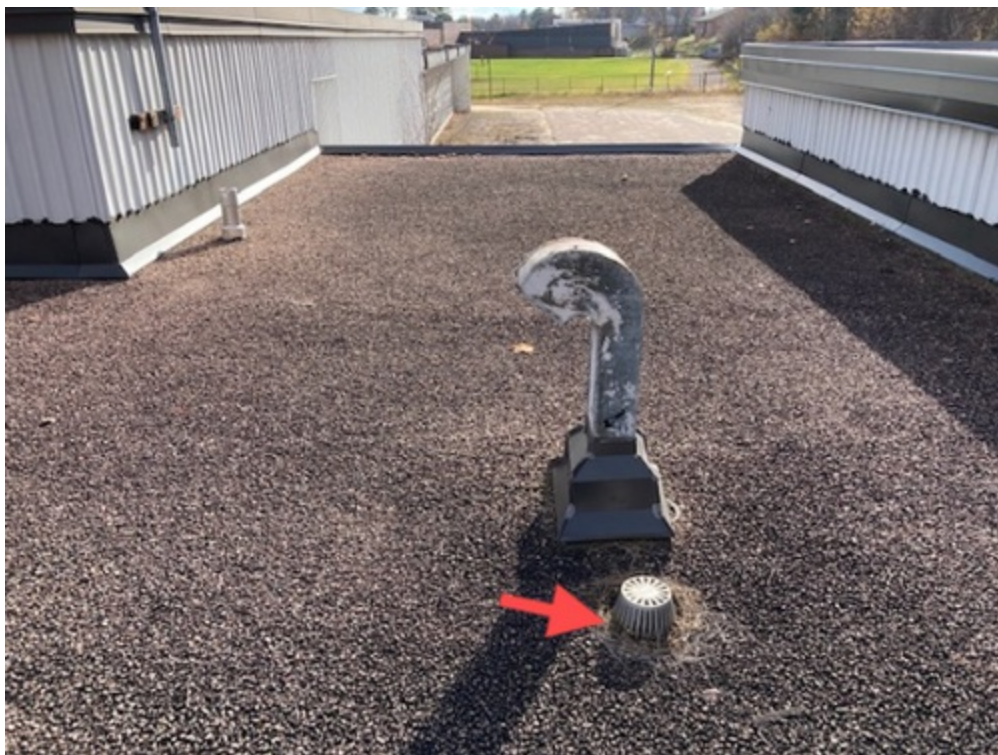
Photo 5

Confirmation of roof debris.

Debris - Leafs and Pine

Needles: Pine needles and other leaves build up on the roof membrane causing plugged drains and scuppers thereby causing ponding water and structural weight loading. As the leaves and pine needles rot a "compost effect" occurs, this in effect causes soil to form on top of the roof membrane. This soil creates a perfect medium for plant and weed growth. When seeds take hold the roots will often penetrate through the membrane causing immediate leaks and damage internally.

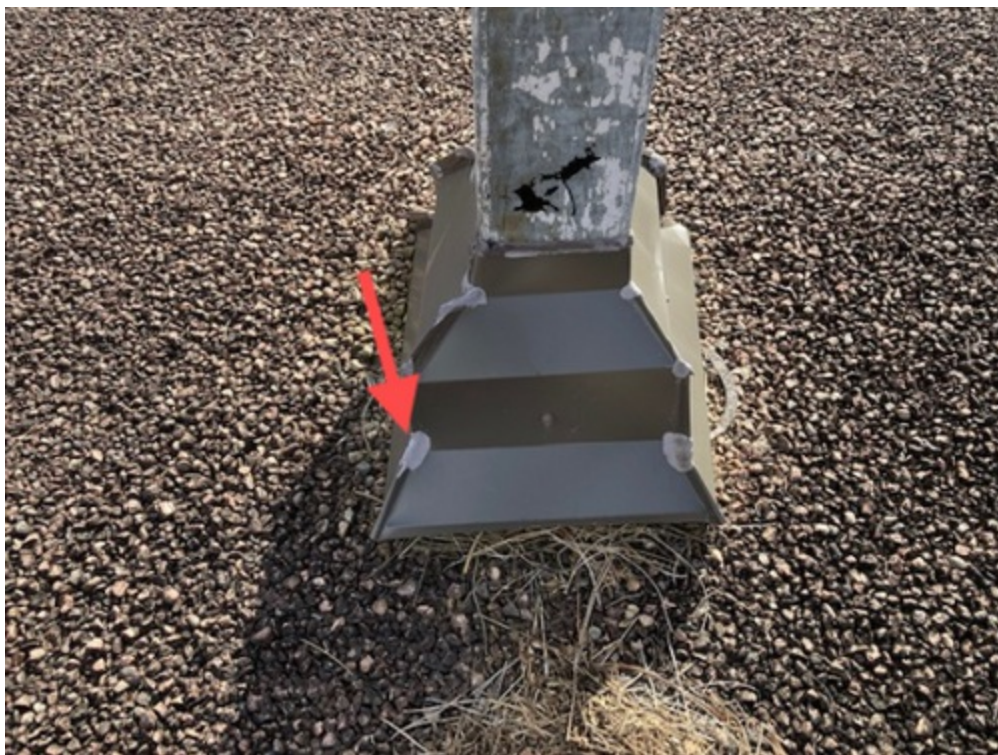
Photo 6

Confirmation of a previous caulking repair.

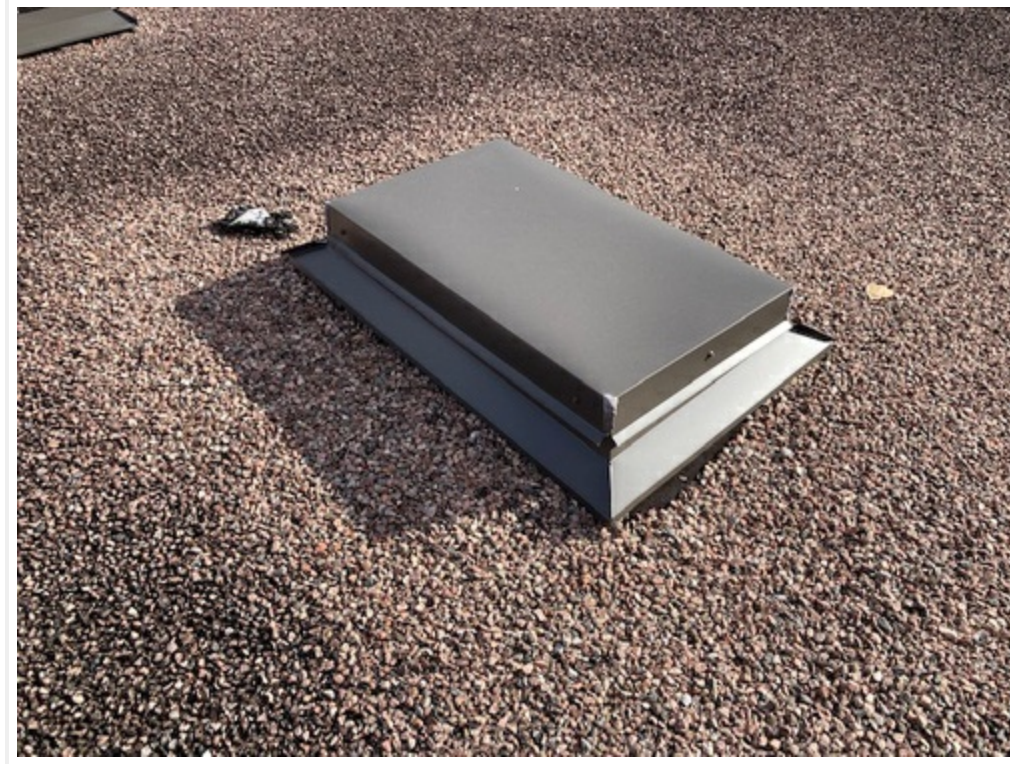
Photo 7

Confirmation of a redundant penetration. During the next replacement, ensure penetration is removed down to the deck.

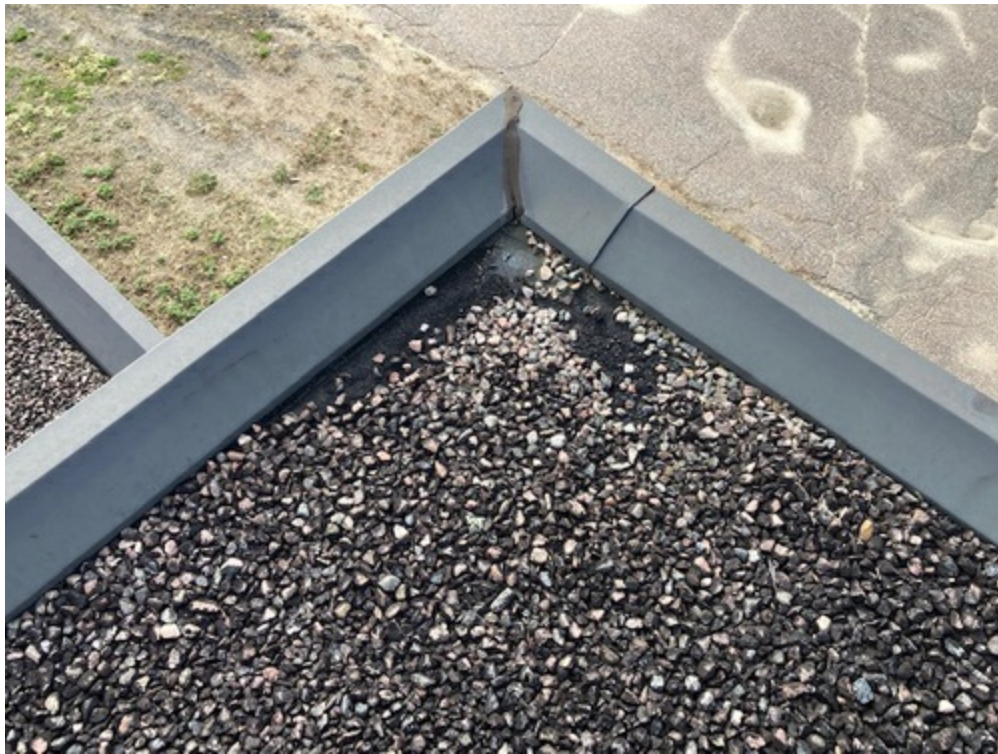
Photo 5

Confirmation of wind scorn area.

Wind Scour is a common phenomenon as wind speed increases as the air is pushed over the roof of the building after it impacts the walls. This is typical to the same properties with an airplane wing. This causes a vortex in air circulation creating negative pressure at the roof surface. Loose aggregate or ballast is easily moved under these conditions. Roof aggregate or ballast serves a few functions, 1) to protect the surface of the roof system from UV degradation while increasing the fire rating of the assembly and 2) to hold the roof system in place specifically on ballasted systems. If areas of the roof are exposed due to wind scour, protection of the roof to the elements is also removed and in the case of ballasted roof systems damage and eventual blow off of the system can occur.

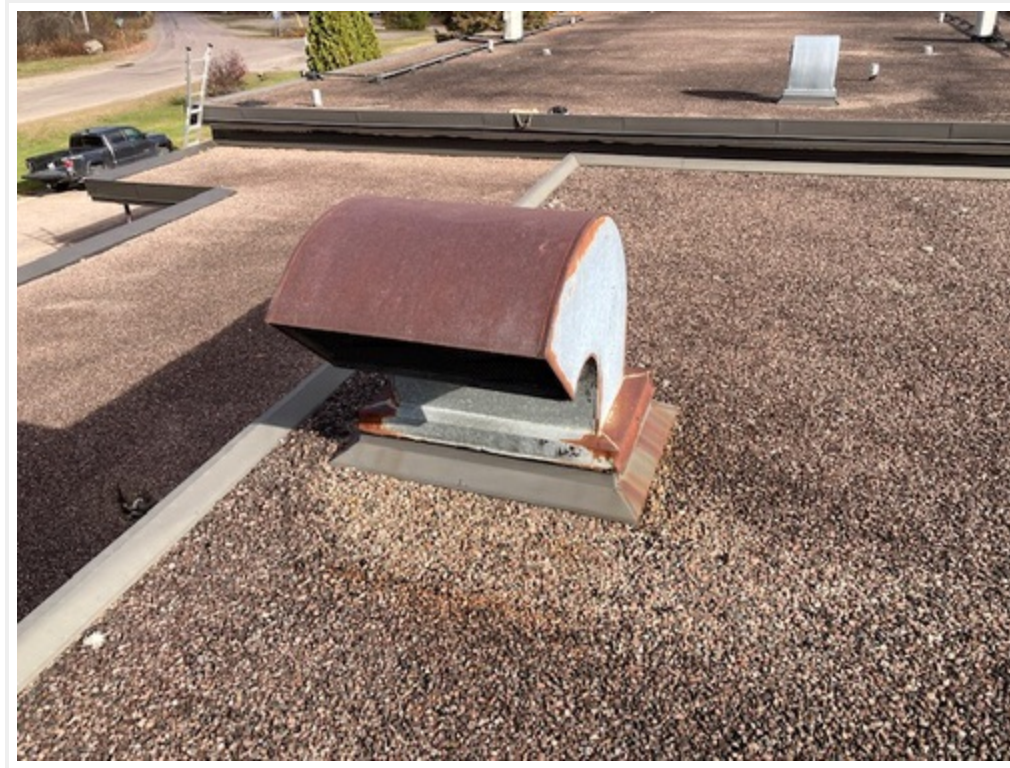
Photo 6

Confirmation of existing vent. During the next replacement, ensure curb is above the finished roof height by 12".
